Land reclamation at an opencast Italian asbestos mine: some problems recently faced

ABSTRACT: The Balangero mine, in North Western Italy, was till the '70ties one of the most important European asbestos producers, with more than 5.000.000 t yearly blasted rock, and a production of 150.000 t/y of asbestos - chrysotile- fiber. The mine exploitation was carried out in opencast, and attached to the excavation site were both the ore beneficiation plant and the waste tailings: the overall area involved by the mining activity rises to 0.8 km², 0.15 km² and 1.5 km² for the extractive activities, the ore beneficiation plant and the tailings respectively. The mining activities having been abruptly stopped in 1990 due to company financial problems, the RSA Co established by public agreement (L.n. 257/92) was charged in 1994 of the restoration of the site, abandoned in quite critical conditions, the task involving a series of quite concerning technical problems, made all the more complex by the presence of asbestos and the associated criticalities in terms of both workers health protection and environmental pollution management. Moreover, a different and cost effective use of the site and ind

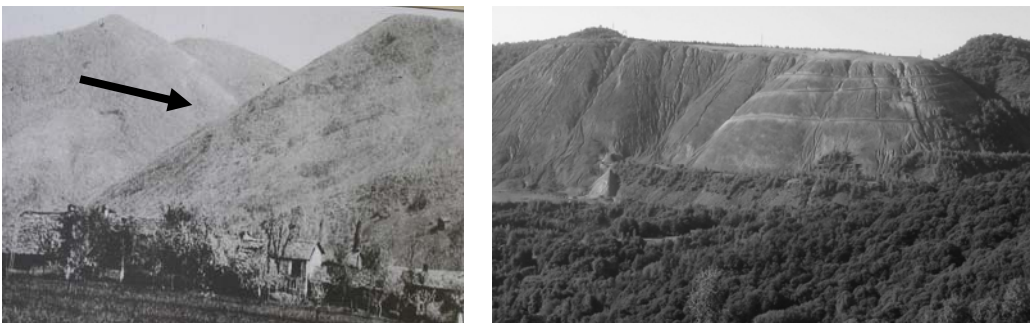
Figure 2. On the left, a 1945 picture of the Fandaglia Valley, the area destined to host the second dump of Balangero mine. On the right the same area as appears today, after a first stage of rehabilitation works.

A serious problem the Balangero mining company had to face was the dumping of both exploitation wastes and processing tailings. Huge volumes of material were involved and the result, in terms of landscape reshaping, is impressive (Fig. 2).

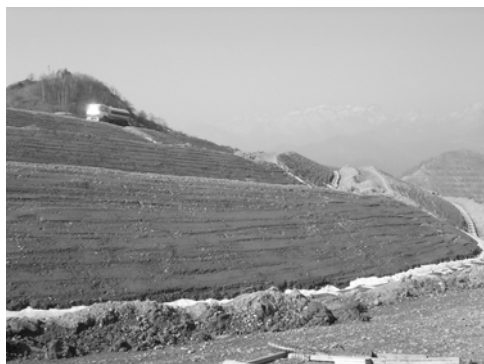
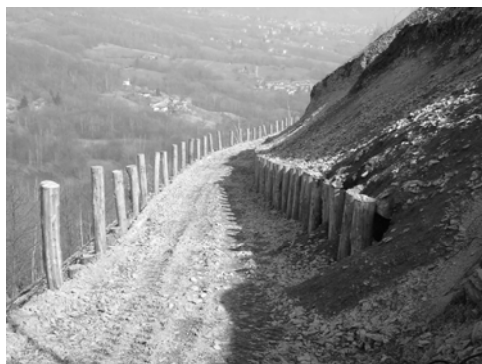
Figure 3. On the left, The reshaping of the upper part of the dump: the benches and the draining works are well visible. On the right, the berms created in the central part of the slope, to stabilize the dump body and intercept the run-off.

- reshaping of the upper part of the slope through the creation of 3 large benches (10 m height, 32° slope), and water control with draining channels (Fig. 3);
- run-off control in the central part of the slope through the creation of a number of little berms (3-4 m large) distant 30-40 m from each other (Fig. 3);
- reshaping of the toe of the slope and creation of a sedimentation basin where all the water drained along the slope has to be collected before reaching the Fandaglia river;
- starting the natural growing of vegetation through a first artificial planting.

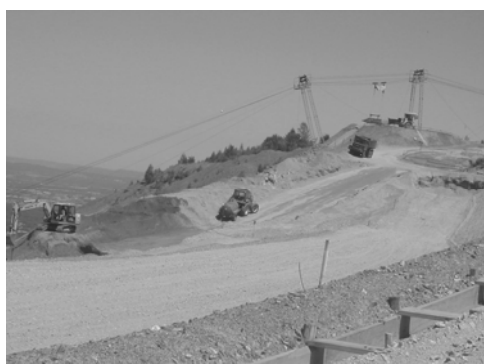
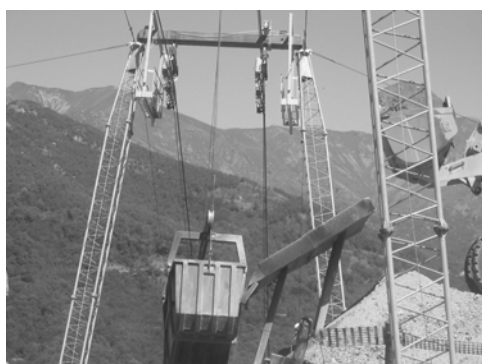
Figure 4. The earth-moving organization in the upper floor of the dump. On the right, a particular of the loading operation of one bucket of the ropeway.

A very critical phase of the work was the earthmoving, due to the topographic set and to the characteristic of the material to be moved. The final work organization resulted in (Fig. 4):

- a main transportation system based on a two-cable ropeway, with independent haulage ropes, single bucket capacity of 3 m³, capable of approx. 50 m³/h on a descent of 400 m;
- an earth moving organization on the upper part of the slope, based on a hydraulic excavator (bucket 0.8 m³), 2 trucks (capacity 12 m³), 1 wheel loader (bucket 0.8 m³).

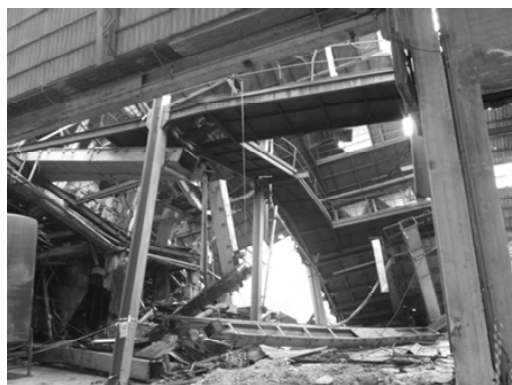
Figure 5. Partial collapse of the steel/reinforced concrete structures sustaining Building “A”.

The building fell down in the past and is not recoverable (Fig. 5). Moreover, previous actions were carried out to remove plants and part of the load-carrying steel members. However, damage is only partial and further sudden collapses cannot be excluded. Although the area is easily reachable from the ground level, the presence of plants and relicts fully impregnated of asbestos forces to choose a sequence of removal operations alternated with induced highly-controlled partial collapses.

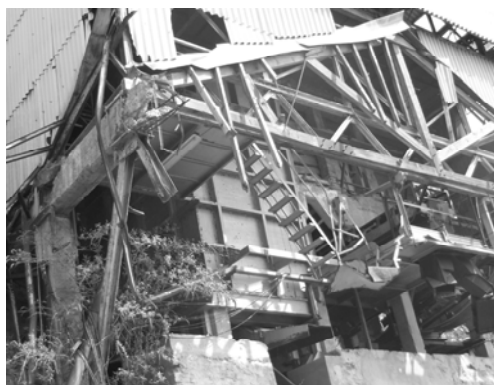
Figure 6. The state of building “B” showing the incipient risk for collapse.

The building is densely occupied with plants containing a high quantity of asbestos fibres. It is the remaining part of a larger building partially demolished during a wrong operation which did not take into account the static characteristics of the frames (Fig. 6). The base of the building, on the valley side, rests on the remaining parts of two cantilever beams (in the original static scheme they were beams supported at both sides), stiffened by means of diagonal steel members. These two beams are severely damaged in correspondence of the support on the columns, due to a combined shear-flexural effect due to the modification of the static scheme. Collapse of these beams would presumably provoke the collapse of the entire building due to domino effect.
